Untersuchungsbericht

Auftragsbeschreibung: Prüfung eines Überspannungsschutzes auf Verträglichkeit mit einem Foundation Fieldbus Segment.

Artikel:	Nummer:
5098452	MDP-4/D-48-EX
5098450	MDP-4/D-48-T
5098380	FDB-2 24-M (metrisch)
5098390	FDB-2 24-N (NPT)

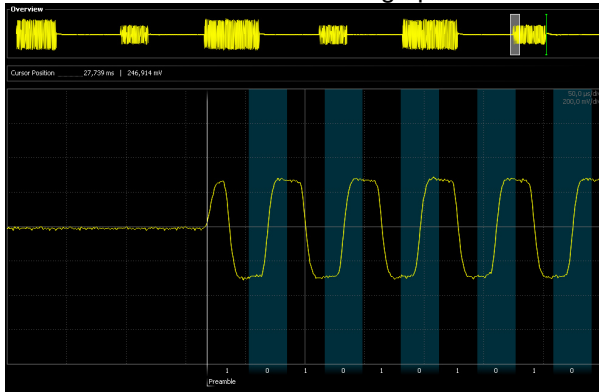
Field device add. 24 without surge protector

Compared to the original condition (without surge protector), there is no influence on the signal quality of the field devices provided with FDB-2 24-... and MDP-4/D-... visible.
